# OPERATION AND MAINTENANCE EQUIPMENT AND PROCEDURES

RELEASE NO. 28

April, May and June 1959

**CATHODIC PROTECTION OF SUBMERGED METALWORK**  
on the  
All-American Canal System  
Boulder Canyon Project

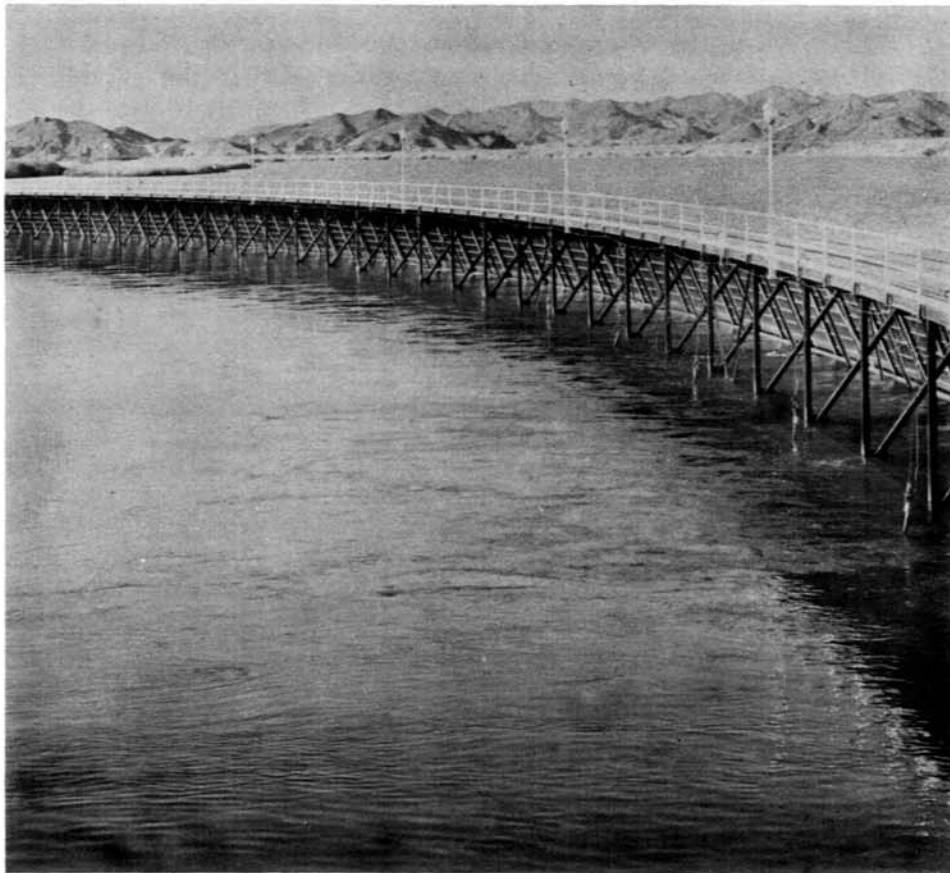
All-American Canal Trashrack at Imperial Dam  
is protected cathodically by anodes shown  
attached to downstream side of structure.  
Photo No. 212-A-9673.

The trashrack for the All-American Canal headworks at Imperial Dam, as shown on the cover of this issue of the bulletin, is an example of a compromise. Here anodes should be placed both in front of and in the rear of the structure. The operation involved in cleaning the trashrack prohibits the use of anodes in front of the rack; therefore, a compromise was made by placing anodes only in the rear of the rack, as shown in the lower photograph, with enough current applied to obtain a fair protection of the front.

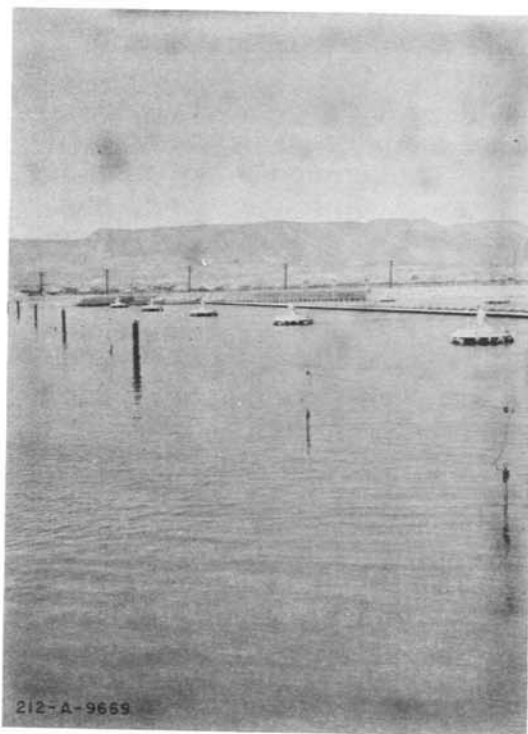
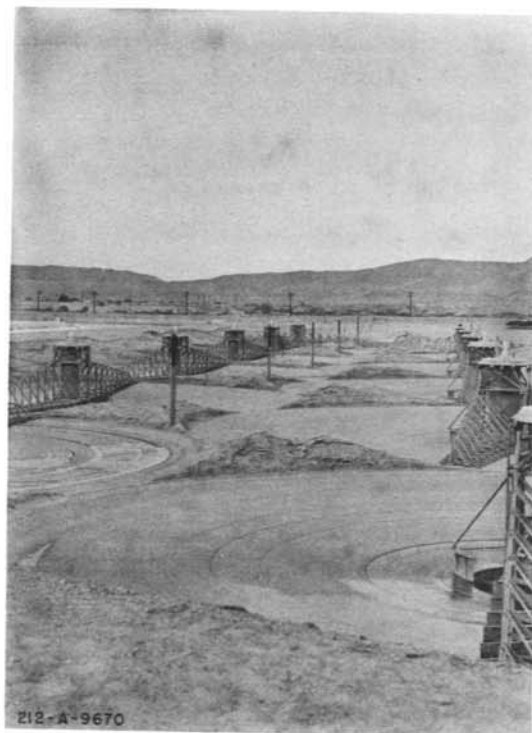
Experience has shown that to protect a given structure or group of structures; e. g., one side of a desilting basin having 12 clarifiers and considerable underground conduit and piping, that it was more efficient to use additional anodes spacing them opposite the clarifiers rather than equidistant from each other. Using 12 equally spaced anodes in one half of a desilting basin, and an impressed current of 29 amperes, or 2.42 amperes per anode, certain anodes were weighed periodically, for one twelve-month period. The rate of dissipation was 6.15 pounds per year for a total of 73.8 pounds for the half-basin. During another twelve-month period using 20 anodes, including 13 suspended opposite the clarifiers and 7 anodes buried in the sand floor, and an impressed current of 26 amperes, 0.30 amperes per anode, the rate of dissipation for a twelve-month period dropped to 2.73 pounds per anode for a total of 54.6 pounds. Thus a 26 percent reduction in rate of anode dissipation was effected while providing more efficient protection to approximately 35,000 square feet of submerged and buried metal surface in this half-basin. Suspension of the anodes in South half-basin No. 3

of the All-American Desilting Basin is shown in the left photograph above. The rotary scrapers in South half-basin No. 2 in the right photograph.

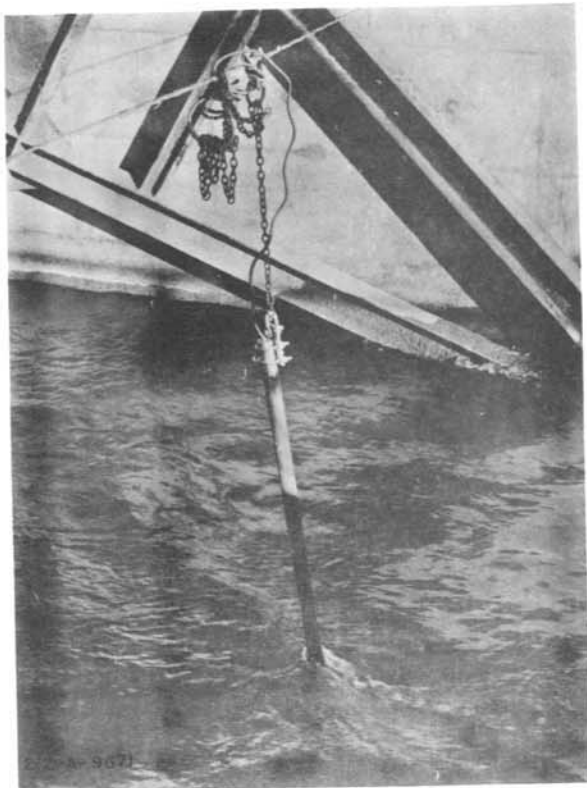
In 1955, a high-silicon, cast-iron, anode was marketed. These were tried experimentally and found to have a very low rate of dissipation. One of the anodes of this type is shown with an adjustable chain suspension in the photograph at left. These anodes are 2 inches in diameter, 60 inches long, and weigh about 48 pounds. Their cost is about \$19.00 per anode. For comparison with the graphite anode mentioned above; while the graphite anode was dissipating at the rate of 2.73 pounds per year, an experimental high-silicon, cast-iron, anode in the same half-basin, lost only 0.75 pound. Because of their greater mechanical strength and promised longer life, the District is changing to high-silicon, cast-iron anodes as replacement becomes necessary.

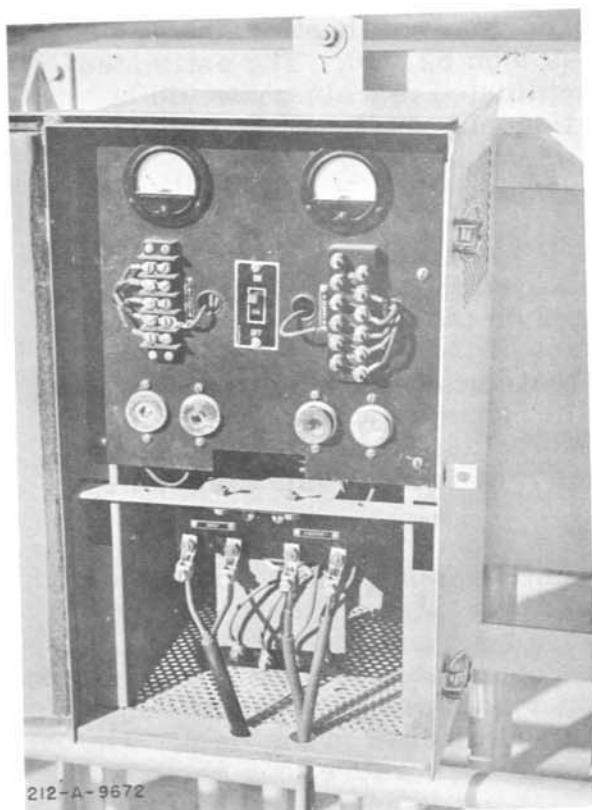
212-A-9672

Many cathodic protection installations employ the dry disc or plate type rectifier which converts the usual alternating current commercial power to direct current. The rectifier unit usually contains a transformer to reduce the input voltage to 20 volts or less, tap-changing links or rheostats to adjust the voltage, and fuses or circuit breakers to protect the equipment from overload. A voltmeter and an ammeter are usually provided in order to assure proper operation. A rectifier unit of a cathodic protection system at a check on the All-American Canal is shown in the photograph at the top of the following page.

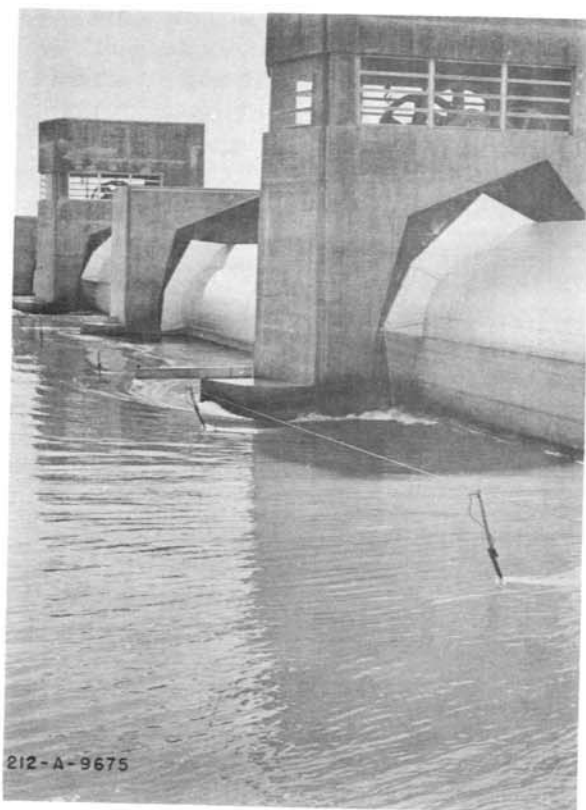
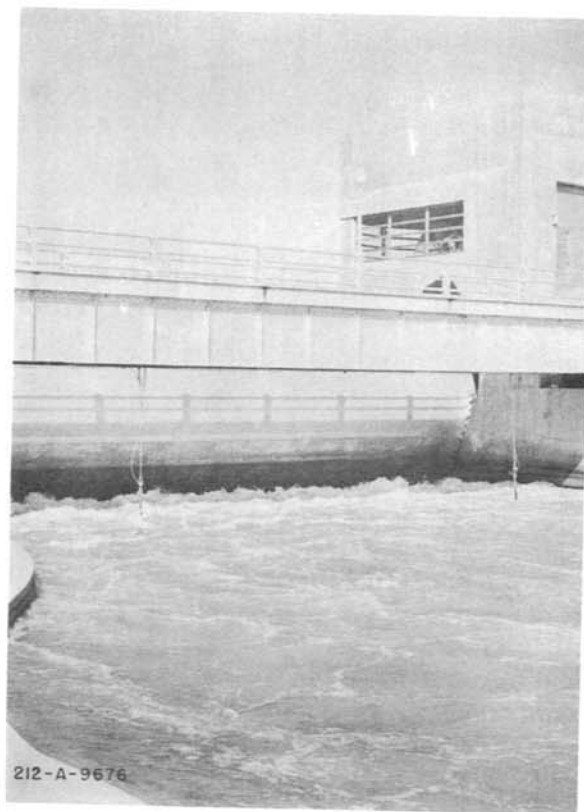
The protective system for the All-American Canal headgates, as shown on the following page is a typical installation for large gates. Two anodes are suspended upstream and downstream from each of the four 75-foot wide gates. The 3/8-inch messenger cable supporting the anodes also serves as the conductor for the rectified current.

lead primer and aluminum coating was in fair condition on the front of the gates, but the ends and downstream portions were seriously corroded. This was especially true of areas near the water surface subjected to water spray from turbulence. The District sandblasted the submerged portions and corroded areas of each gate and applied an acid-cured zinc, in inorganic vehicle, coating. The above water portion of the gates was wire brushed and spotted with vinyl resin primer followed by vinyl resin aluminum paint.

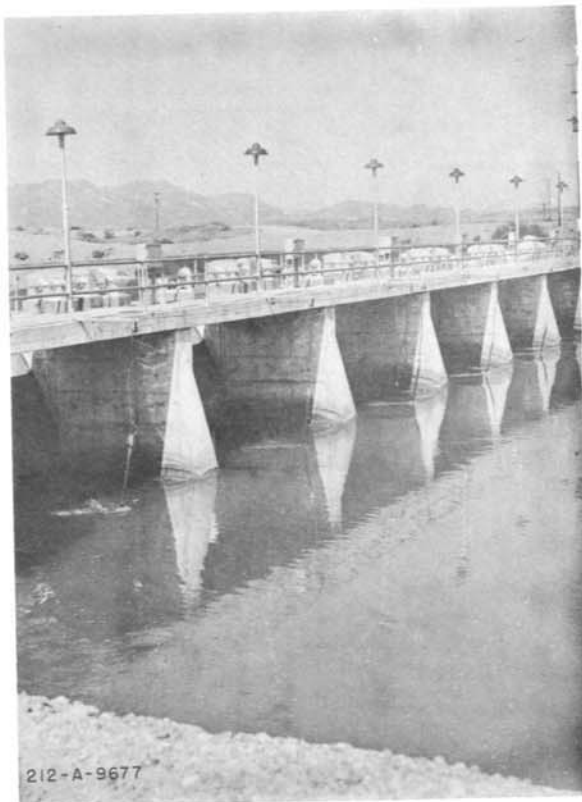
The downstream side of the radial gates is more of a problem. The portion of the gate submerged by backwater is protected by the normal installation except that the anodes may have to be placed far enough downstream to avoid excessively turbulent water. Such an installation is shown in the photograph on page 4. To balance the current between the front and rear of the gates, it is necessary to use resistance in the leads to the anode lines.

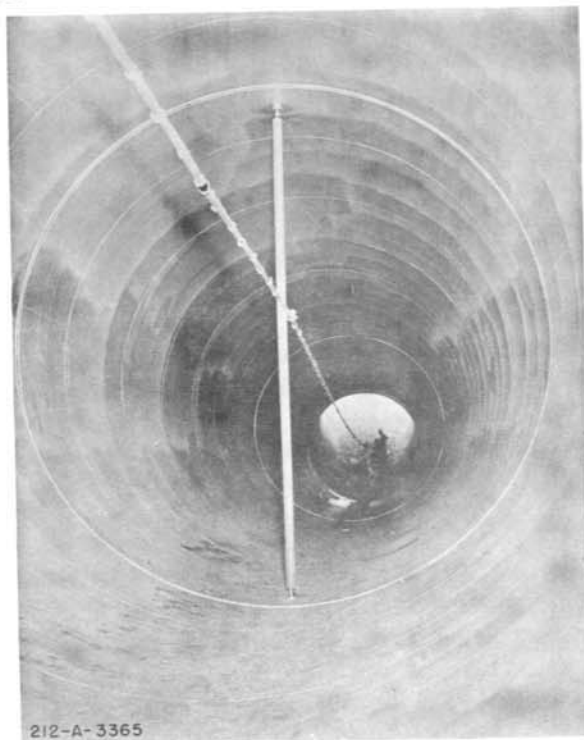
Application of cathodic protection to the New River Siphon was complicated by the large size of the structure. This siphon consists of two steel barrels, one of which is shown in the lower photograph. Each barrel is 15'-6" in diameter with an overall length of 476 feet and the water velocity is about 7 fps. Two types of anodes are used. The anode in the west barrel, the one shown in the photograph, is of magnesium and depends on galvanic action between the magnesium of the anode and the iron of the barrel for cathodic protection. The second, or east, barrel has a steel rod anode and cathodic protection is provided by a rectifier.

Both anodes extend throughout the length of the barrel and are suspended in the center on a steel messenger cable covered by a plastic tube. Regulation of cathodic protection current in the magnesium anode installation is provided by an external resistor. District experience shows that the protection afforded the siphon barrels by either the impressed current system with iron anode or the galvanic system with magnesium anode is equal and sufficient. The fouling of anode supports by floating trash has not been serious.

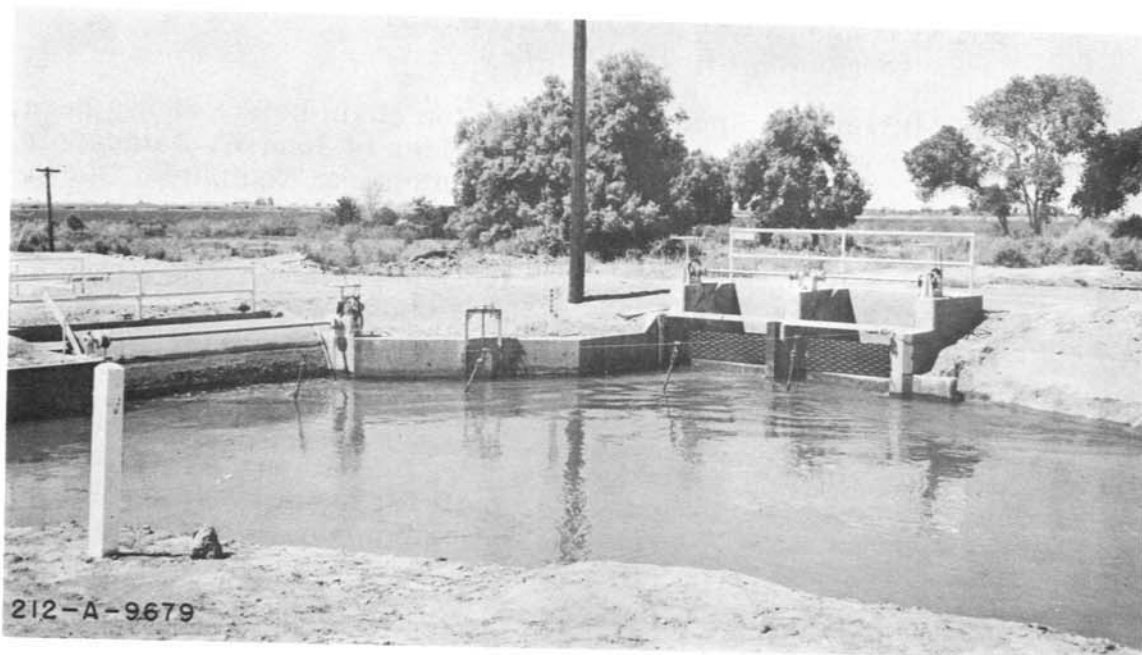
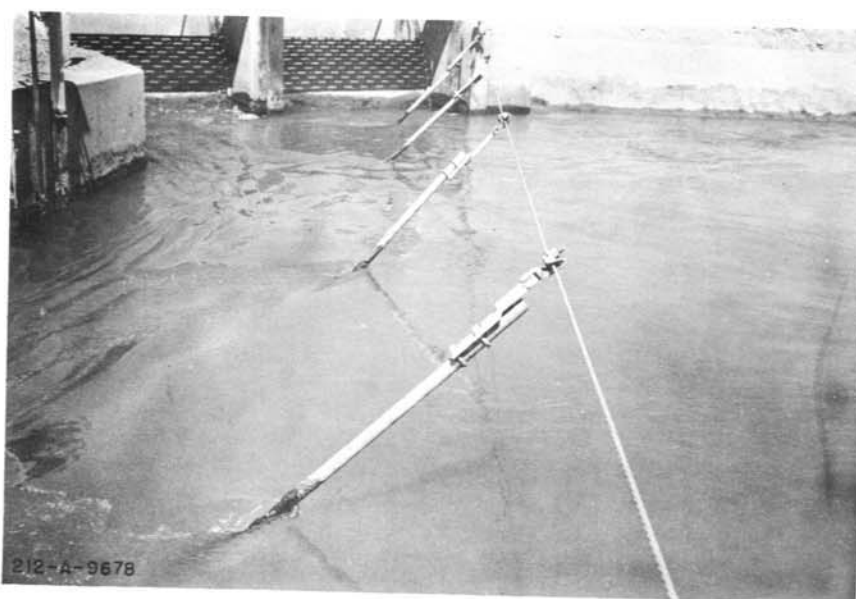
A general view of the check

and turnout arrangement of the anodes is shown in the upper photograph. The anodes of this protective system are magnesium.

The method used in suspending the anodes and more detail of the suspension device and attachment of the anodes to the messenger cable are shown in the photograph at left.

Smaller structures on the All-American Canal system are also being protected by cathodic methods. An example of some of the smaller installations is the check and turnout illustrated in the photographs on the following page.

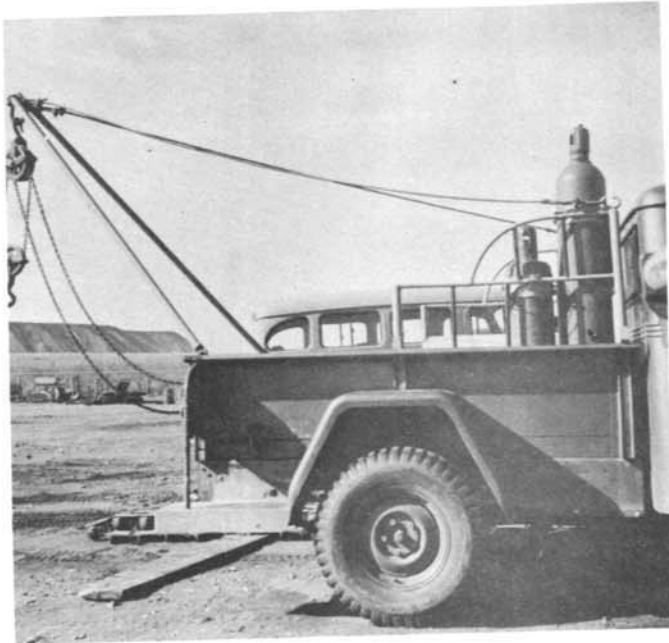
The small boom equipped with a 3/4-ton chain hoist, shown here, mounted on the rear of a pickup truck, was an idea of John W. James, Jr.,

Maintenance Equipment Operator, of the San Marcial Field Branch of the Middle Rio Grande Project, New Mexico. The boom has been very efficient in handling parts assemblies that weigh in excess of 1,200 pounds.

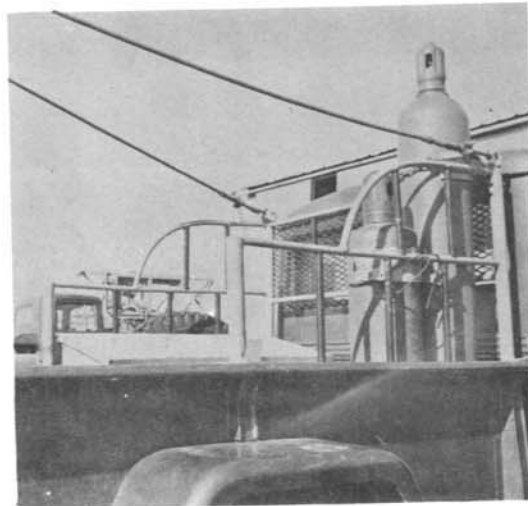
The boom was constructed of 1 1/4-inch pipe and 1 1/4-inch steel stock tapered to fit into the pipe. The boom is held in position for operation by one-half inch cable attached to

a pipe standard fitted into the stake welds in the sides of the bed. The boom can be quickly assembled and dismantled at the site of the work and can be fastened to the sides of the truck bed for transportation from one job to another. Details of construction are shown in the drawing on the facing page.

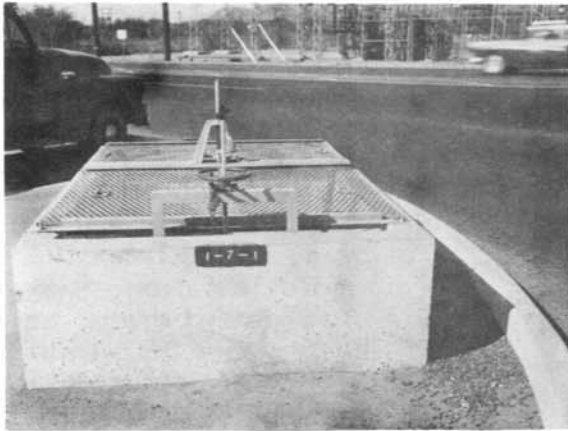
The pleasing appearance as well as the safety provided is well illustrated in the photograph of the protective cover on the distribution box in the suburban areas of the Salt River Project, Arizona.

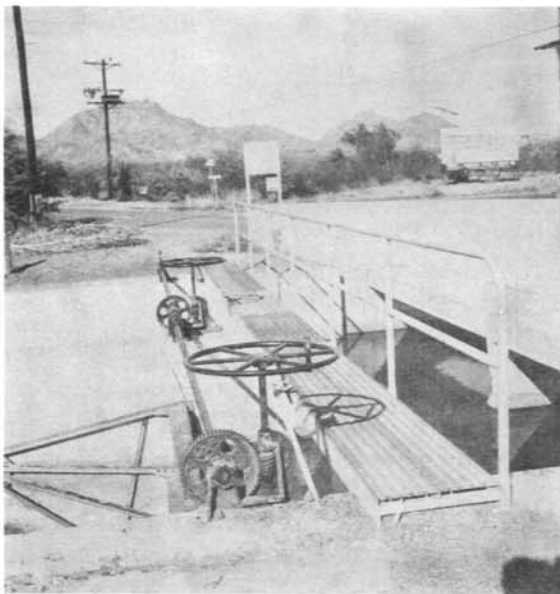
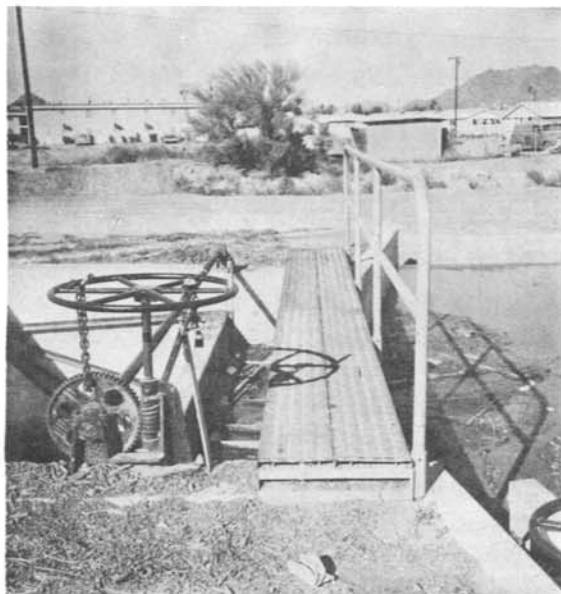
The operating walkway on the structures shown below, provided by the Salt River Valley Water Users' Association, are also pleasing in appearance as well as functional, and well suited to the populated Phoenix Area.

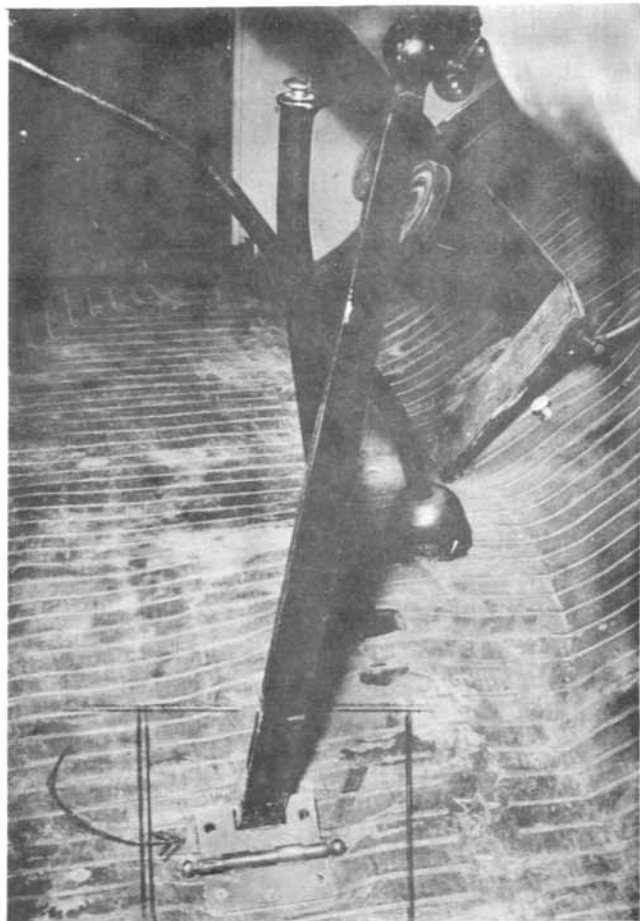
When the power take-off lever on a  $1\frac{1}{2}$ -ton truck was accidentally tripped, damaging the winch, Mr. Jacob Gobel, headquartered at Oak View, California, on the Ventura Project in Region 2, suggested the simple device shown in the photograph at left, to prevent a similar accident in the future.

The very ordinary hinge, slotted to closely fit the power take-off lever at floor level, can be quickly fastened in place.

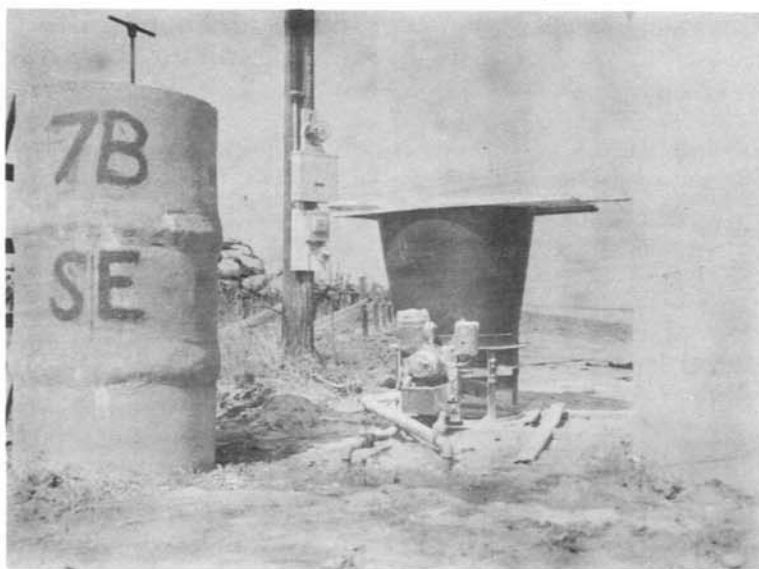
In the Delano and Bakersfield areas, where electricity is usually available nearby, the Deco auger type dispenser is widely used. A typical installation is shown in the upper photograph at left.

A circular plate, forming the bottom of the hopper, is revolved slowly bringing the gypsum into contact with an auger which feeds the dry material into a mixing basin where it is mixed with water and pumped back into the irrigation flow.

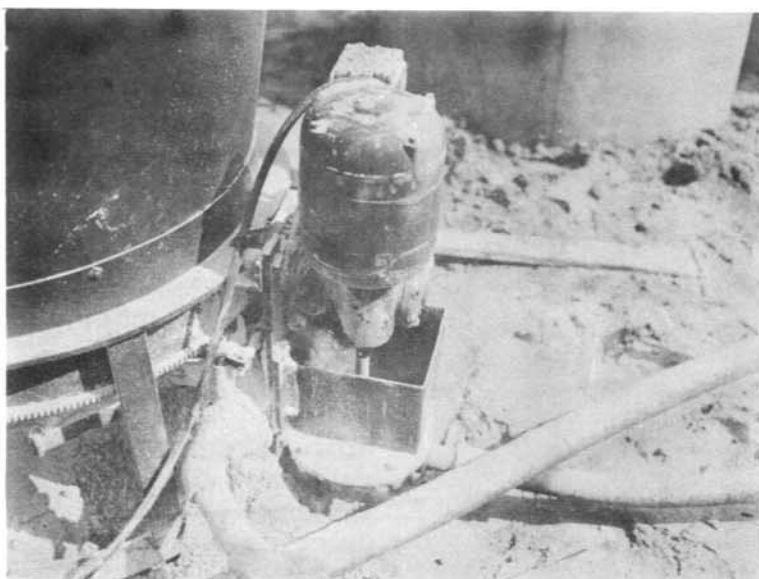
The lower photograph shows the mixing basin below the motor and the location of the notched revolving bottom plate. The auger extending into the hopper is partially enclosed and rate of delivery can be controlled by regulating the size of the opening of the auger box. The gypsum can be mixed at rates of from 25 to 800 pounds per hour. The hopper has

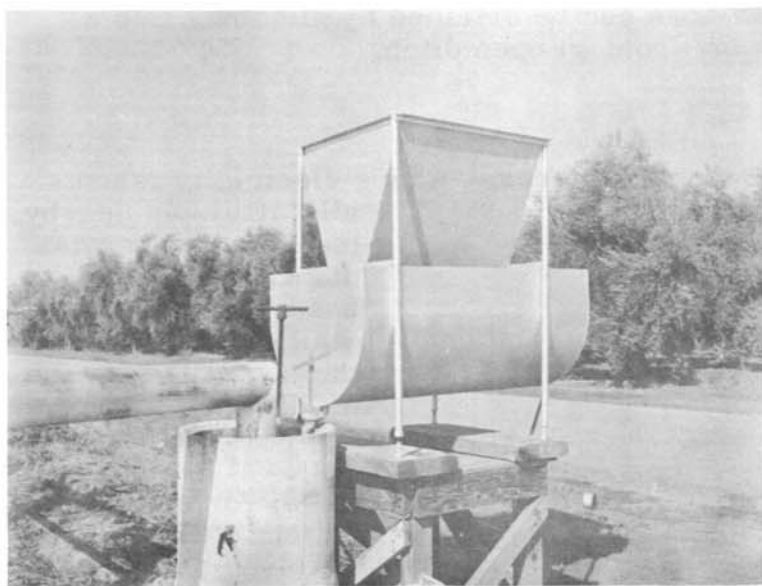
Growers in the Exeter Irrigation District, who wish to build their own dispenser, can obtain particulars for the device shown on this page from the Exeter Irrigation District, Exeter, California.

The homemade device as shown has a capacity for holding 700 pounds of gypsum, and the machine uses water bypassed through the unit to operate a simple mechanism to meter gypsum from the hopper.

When the device is installed in a pipe line system as shown in the upper photograph, no other source of power is required. The rate of delivery of the chemical can be regulated by adjusting the amount of water entering the unit.

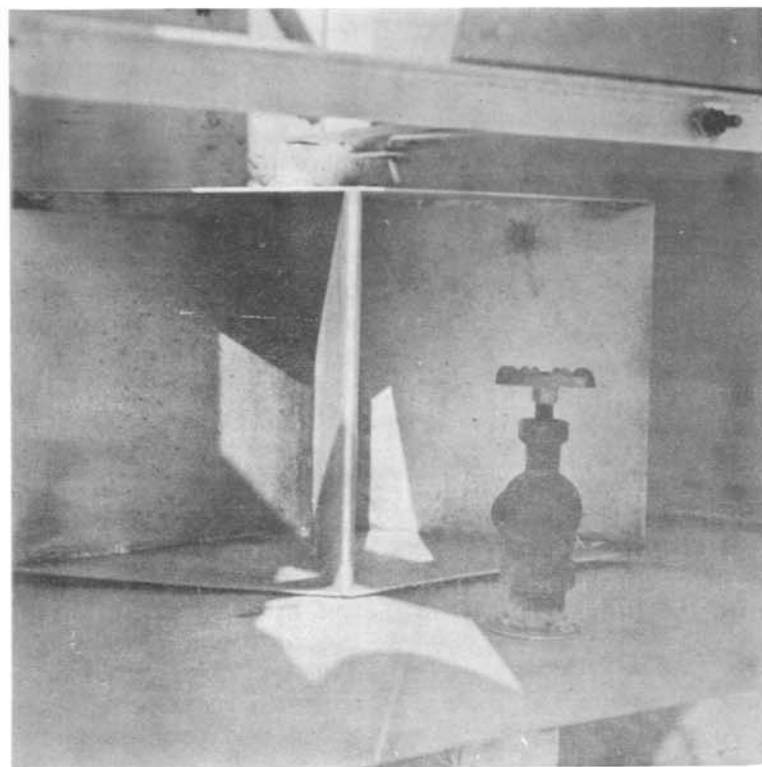
Water entering the unit alternately fills two bucket like containers mounted on a shaft; turning the shaft back and forth to move a metering bar at the bottom opening of the hopper from one side to the other. The lower photograph at left, shows the arrangement of the two buckets which power the shaft and the water inlet located above the buckets. The hopper which contains the dry gypsum is located in the upper left corner.

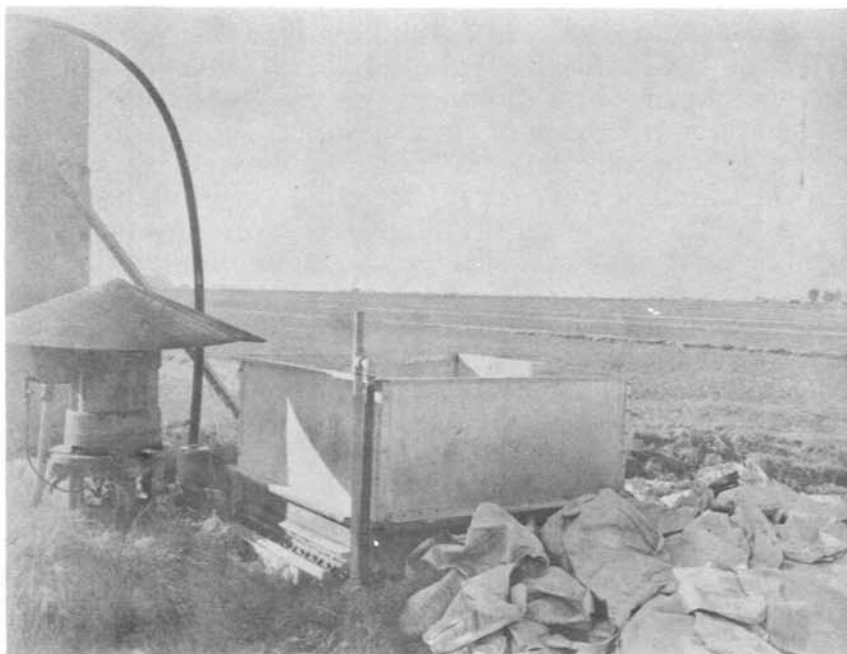
The Jaeco Hydrator has no moving parts. Jets of water from nozzles on the manifold are directed into the hopper hydraulically eroding the dry gypsum, which is returned with the water to the irrigation

stream. In the installation of this type of device as shown at the left, a sump pump is necessary to pump the treated water into the stand-pipe. When installed in a manner similar to that shown for the Exeter model, no power source is required.
